# Manhole Inspection Summary

Manhole # S04GG2007MH

**Location** Address: **7101 BOXFORD RD**

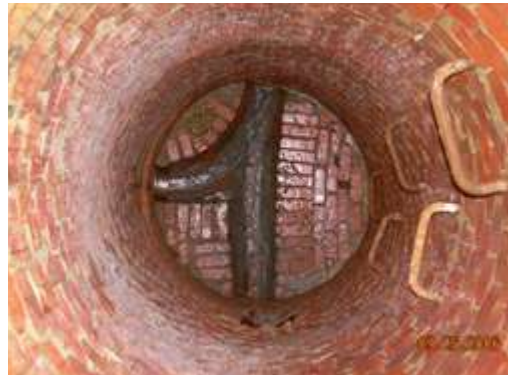
Top View

Adjustment and Corbel infiltration.  
Corroded steps. Bench debris.

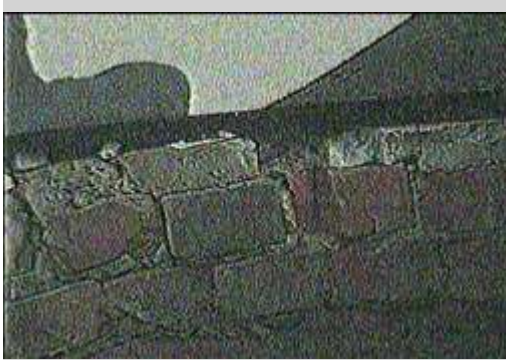
Defect

Frame leaks. Adjustment deterioration,  
loose brick and infiltration.

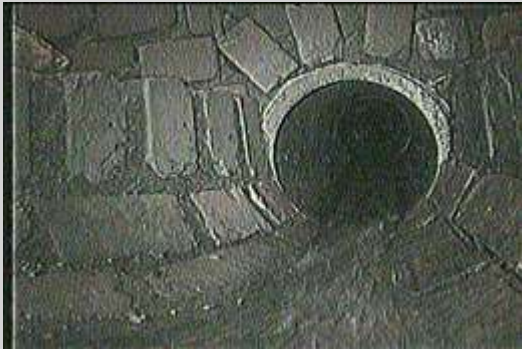
### 8 in. Circular Gravity Sewer Pipe Out @ 12 O'Clock

Infiltration: **Evidence** Pipe Seal Cond: **Unknown**

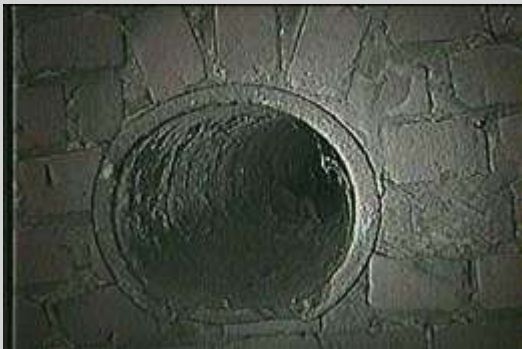
### 8 in. Circular Gravity Sewer Pipe In @ 6 O'Clock

Deposits: ☐ None ☐ Mud ☐ Sludge ☐ Debris ☒ Grease

Infiltration: **Evidence** Pipe Seal Cond: **Cracked**

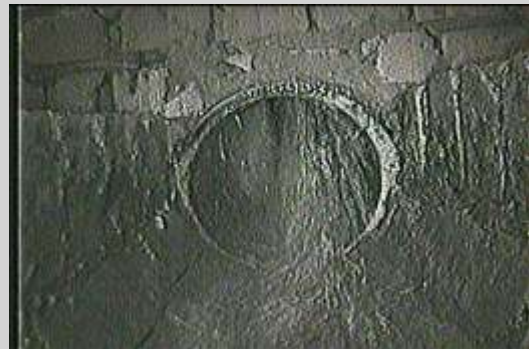
### Drop In @ 6 O'Clock

Channel deterioration.

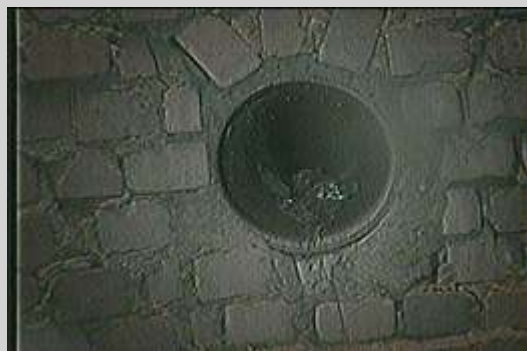
Pipe In @ 9 O'Clock

Barrel deterioration and infiltration.
